Manhole Inspection Summary

Manhole # S15QQ1016MH

Insp Date: **11/20/06 1:16 PM**

Location Address: **4828 GREENSPRING AVE**

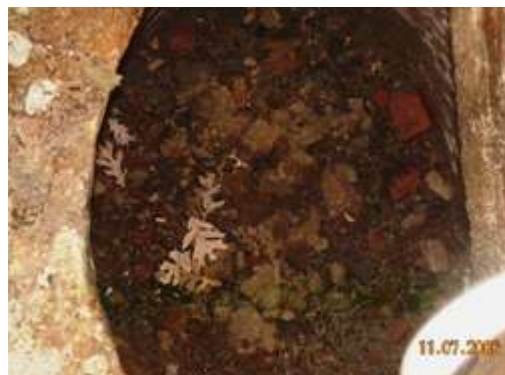
Top View

Channel debris.

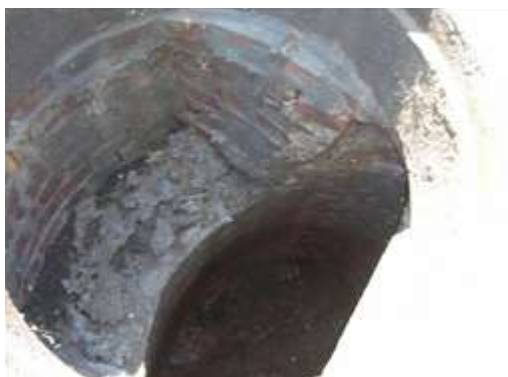
Defect

Frame leaks. Adjustment and Corbel deterioration and infiltration. Barrel infiltration.

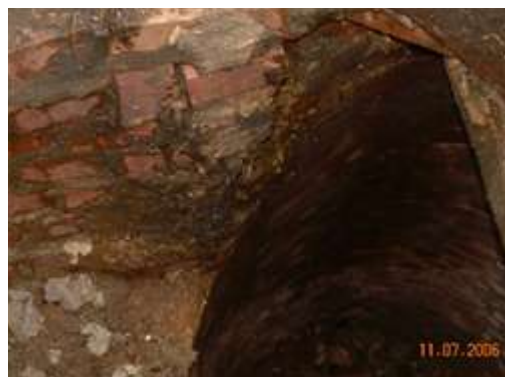
Defect

Frame leaks. Adjustment loose brick, deterioration and infiltration. Corbel and Barrel infiltration.

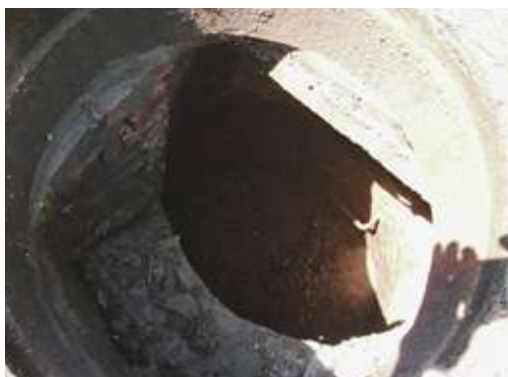
Defect

Frame leaks. Adjustment and Corbel deterioration and infiltration. Barrel infiltration - other side.

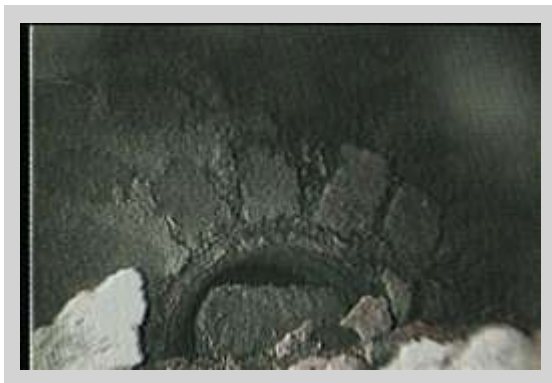
Pipe Out @ 12 O'Clock

Barrel deterioration and infiltration.
